THAMES RIVER BASIN
STAFFORD, CONNECTICUT

POMEROY DAM
CT 00479

PHASE I INSPECTION REPORT
NATIONAL DAM INSPECTION REPORT

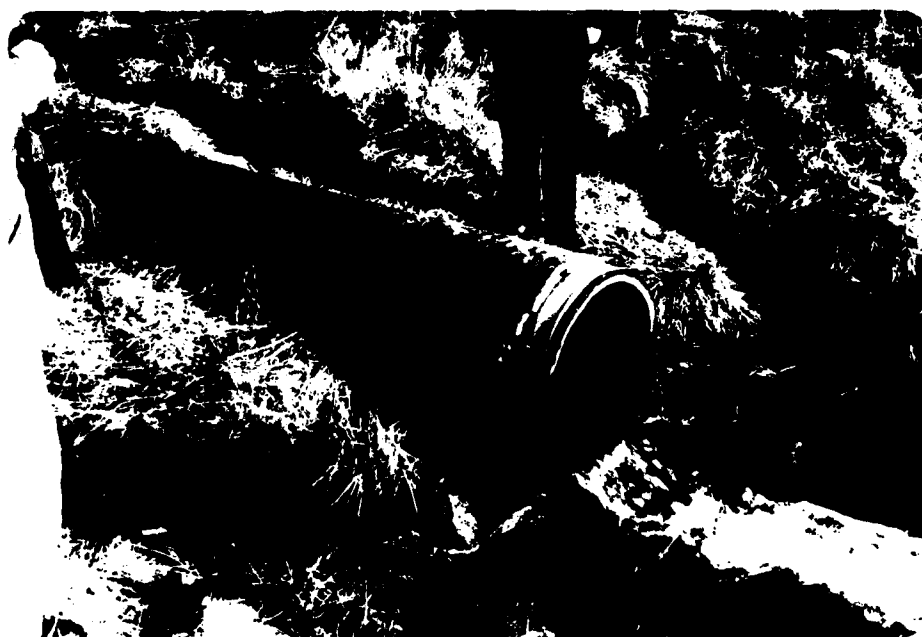
There is a 24 inch concrete water pipe from the riser through the embankment to the outlet. The portion of the pipe that is visible is in good condition and is shown in Photo No. C-6. There is no evidence of channel erosion at the outlet. The last pipe at the outlet is 16 feet in length and is supported

C-6 PRINCIPAL SPILLWAY OUTLET
